SUPPLEMENTAL INSTRUMENTATION APPENDIX

TO PERIODIC INSPECTION REPORT NO. 4

BUFFUMVILLE LAKE

CHARLTON, MASSACHUSETTS

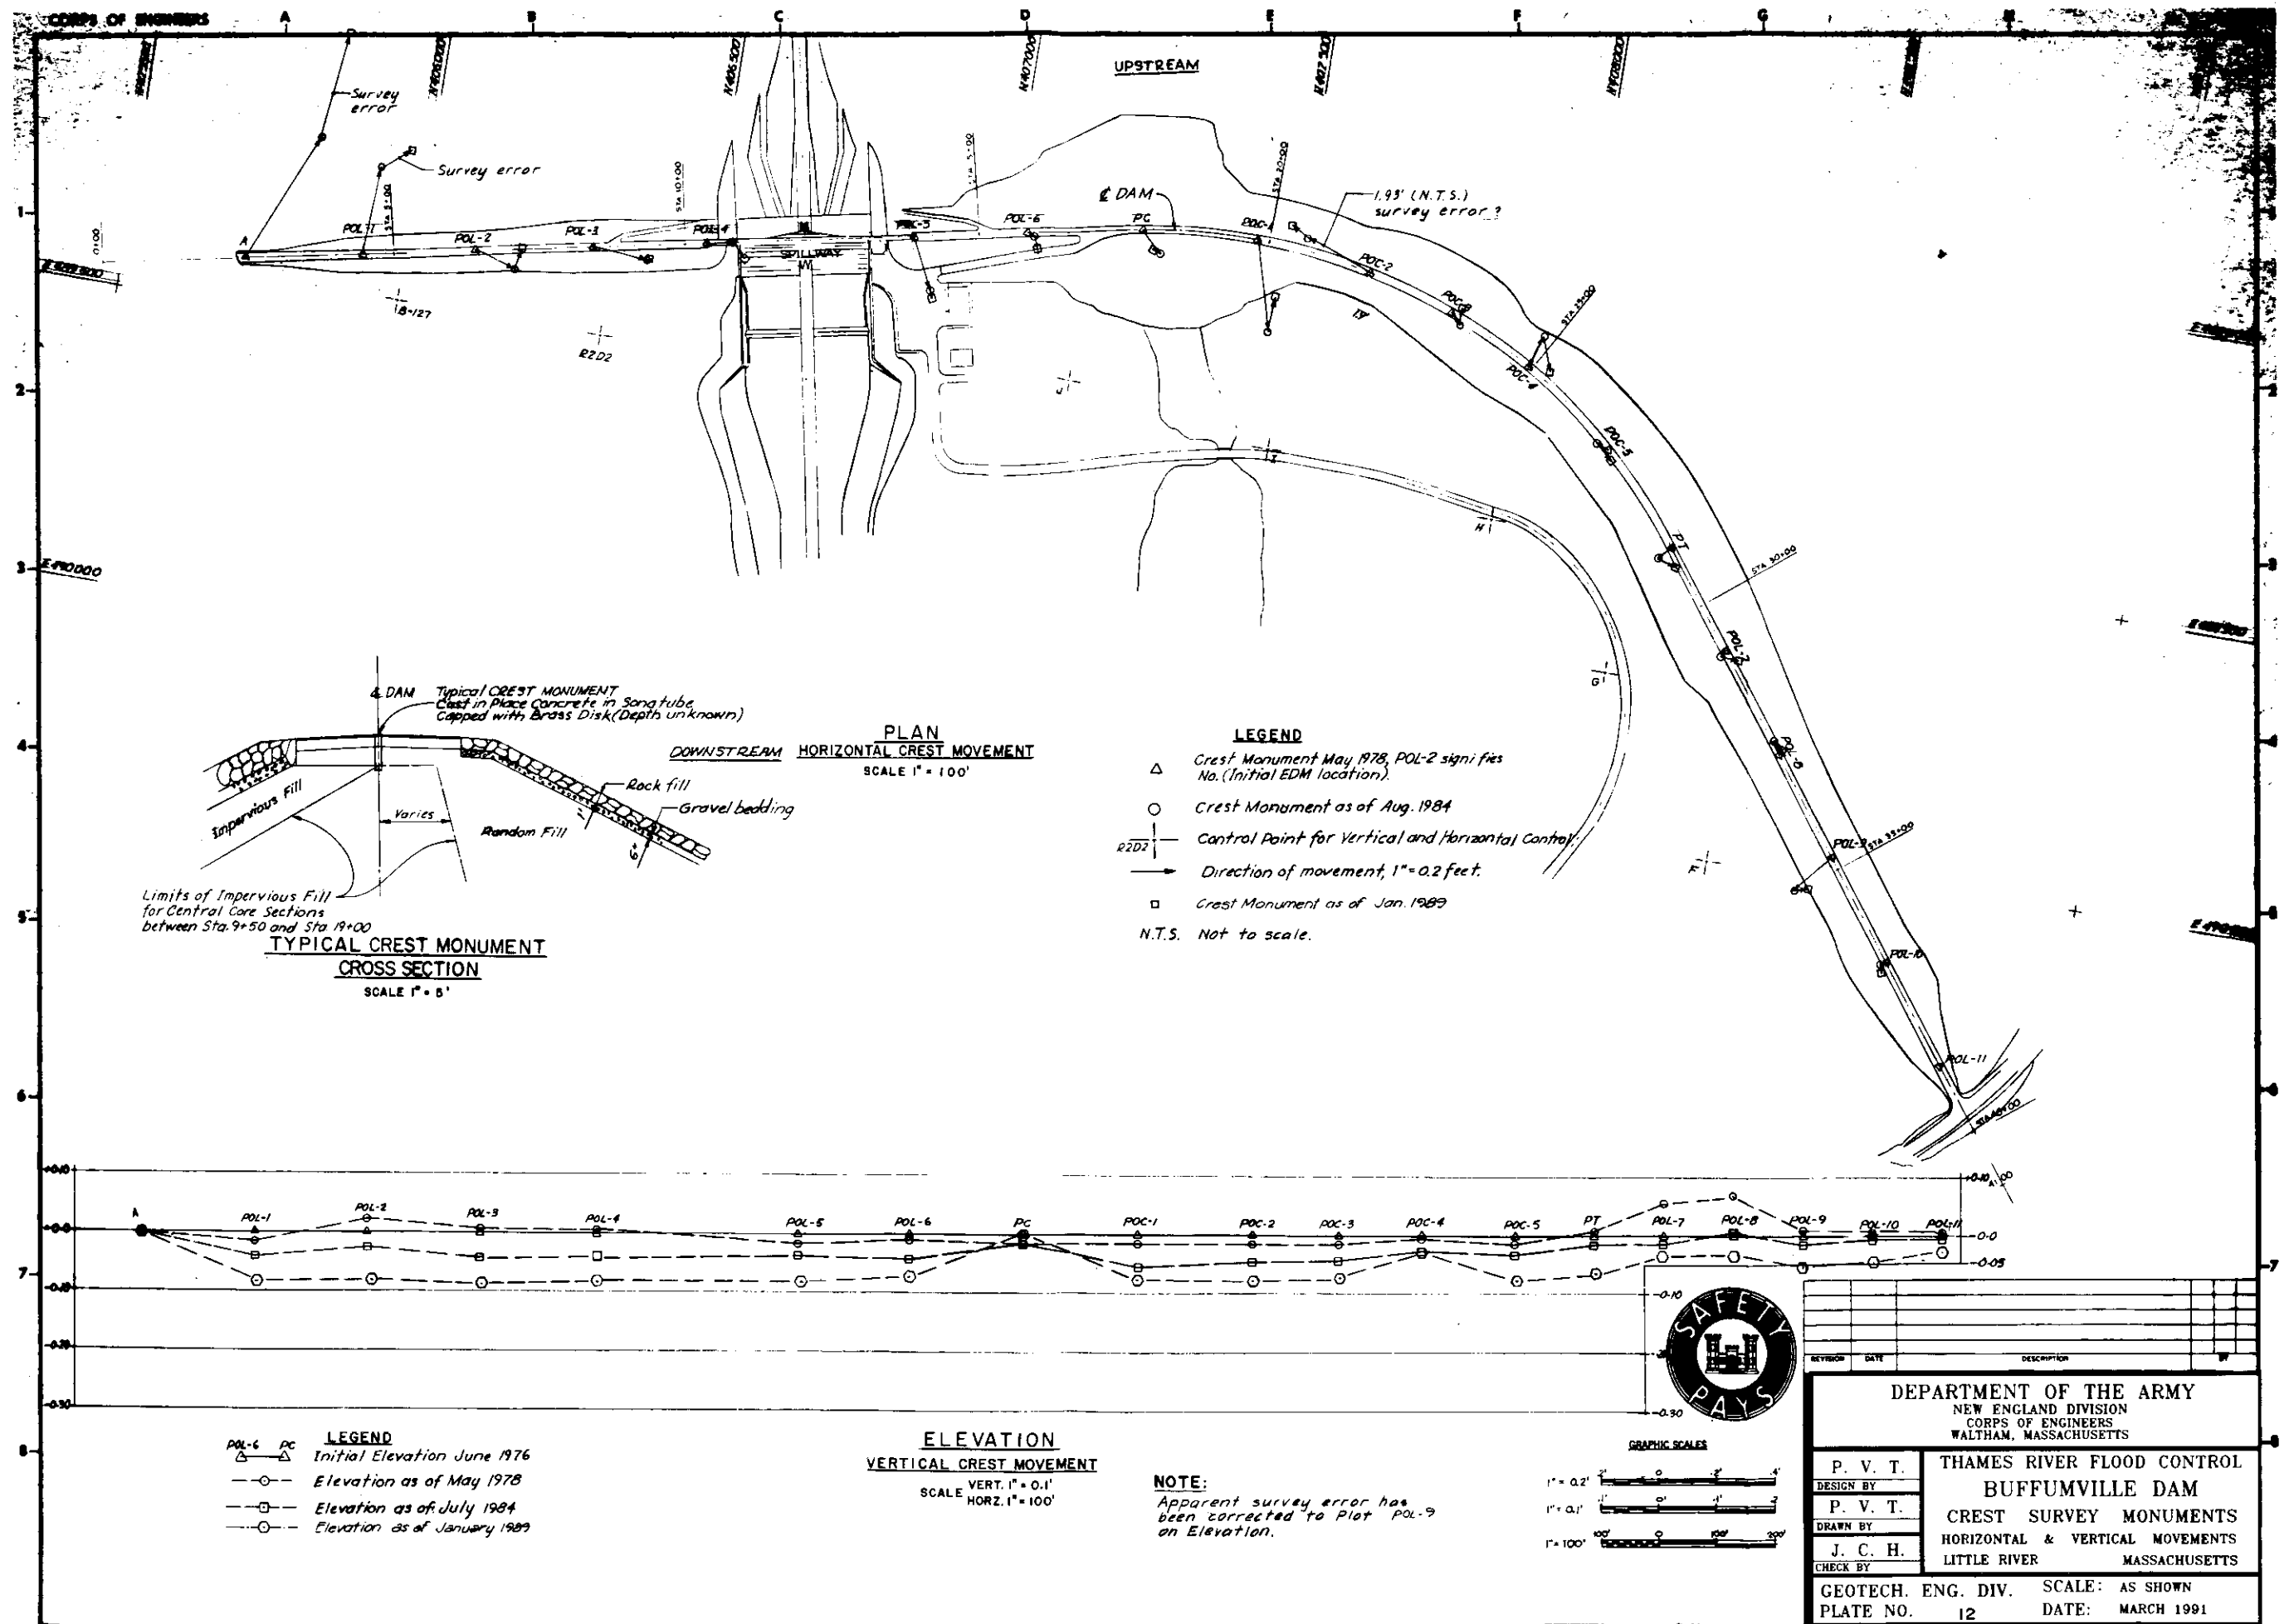
Plate 12 shows graphical representation of the survey results. The observed vertical movements from 1976 to 1989 typically varied between 0 and 1 inch and averaged 0.7 inches. The observed horizontal movements from 1978 to 1989 typical varied between 0 and 2.5 inches and averaged 1.2 inches. Larger movements (10 inches horizontal at A, 4.6 inches horizontal at POL-1, 24 inches horizontal at POL-2 and 7.8 inches vertical at POL-9) were observed, but they are attributed to survey error. There seems to be no trend in the horizontal movements and a small downward trend in the vertical movements.

(1) General. Maximum horizontal and vertical movements of 2.5 inches and 1 inch have been observed at Buffumville Dam. The maximum movements appear reasonable to expect at a project of this type.
